Royal Wood Floors a Milwaukee Hard Wood Floor Company Addresses Job Site Problems in New Series of Educational Articles

Royal Wood Floors helps home owners understand more about the different issues that can happen with their hard wood floors

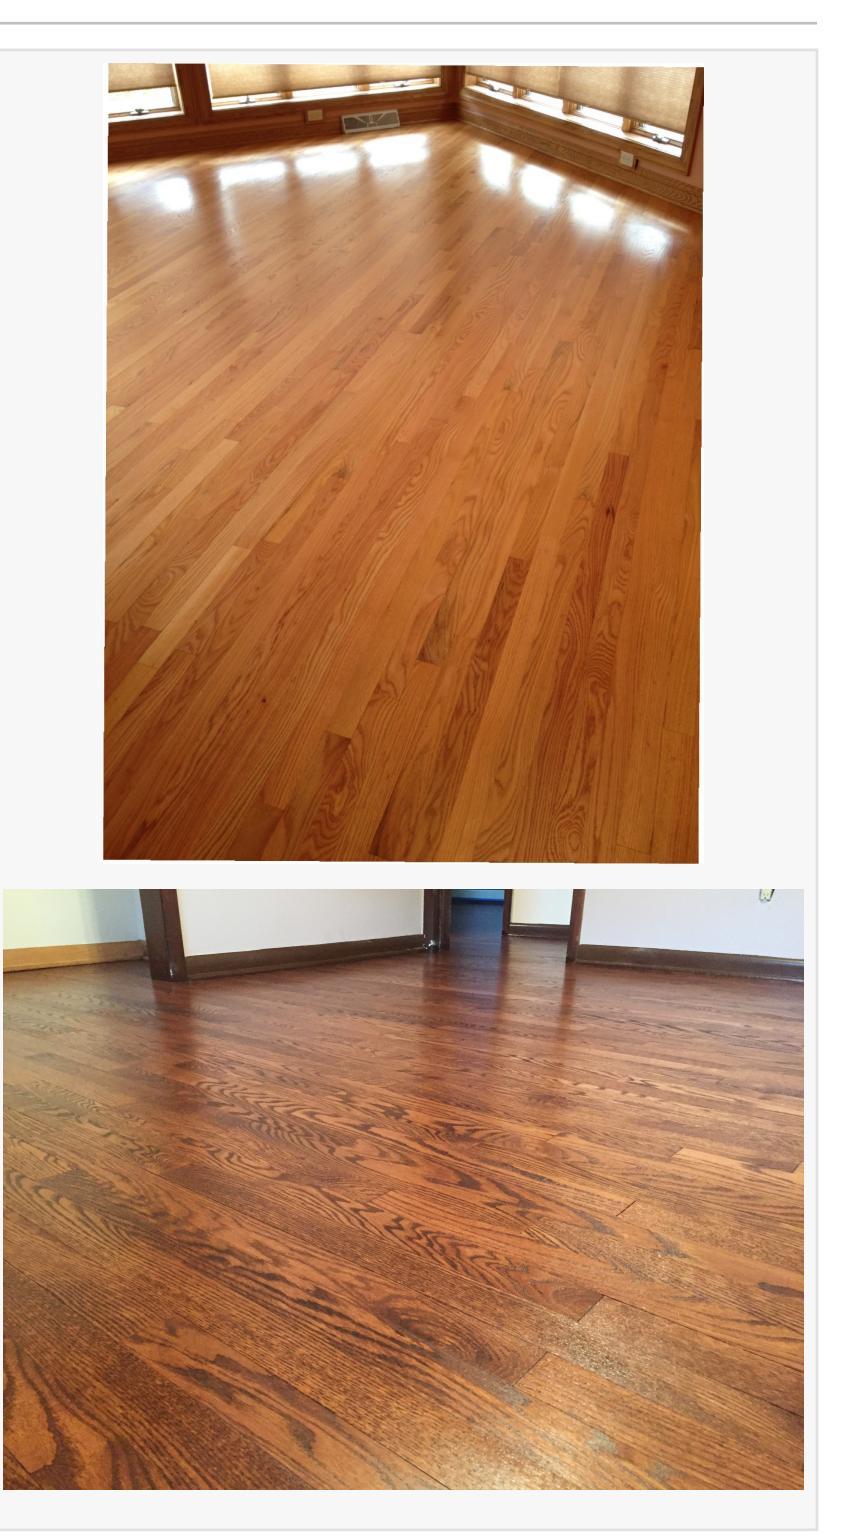
Buckling is excessive expansion causing the wood flooring to release from the sub-flooring. This is an issue that is always caused by excessive moisture.

This can be caused by pipe leaks, a wet slab, poor grade to the foundation and excessive humidity. Sometimes for floors that installed improperly can cause buckling. Buckling can be caused by hard wood floor installations that were nailed down incorrectly. Incorrect fasteners or incorrect sub-floor construction can all cause this issue. "Incorrect or insufficient adhesive can cause a floor to buckle", says Allman. "We look at a variety of causes for the home owner so that floor buckling can be fully resolved in the future", he continues. Cures for buckling include fixing the high moisture conditions that can include the use of dehumidifiers which allow the floor and sub-floor to dry to normal levels. Releasing the stress on the floor by providing relief at all vertical obstructions such as walls, cabinets and other areas is important. In many cases, if buckling is caught early enough then just spot repairs can be done. However there are circumstances where a complete new hard wood floor installation will be necessary.

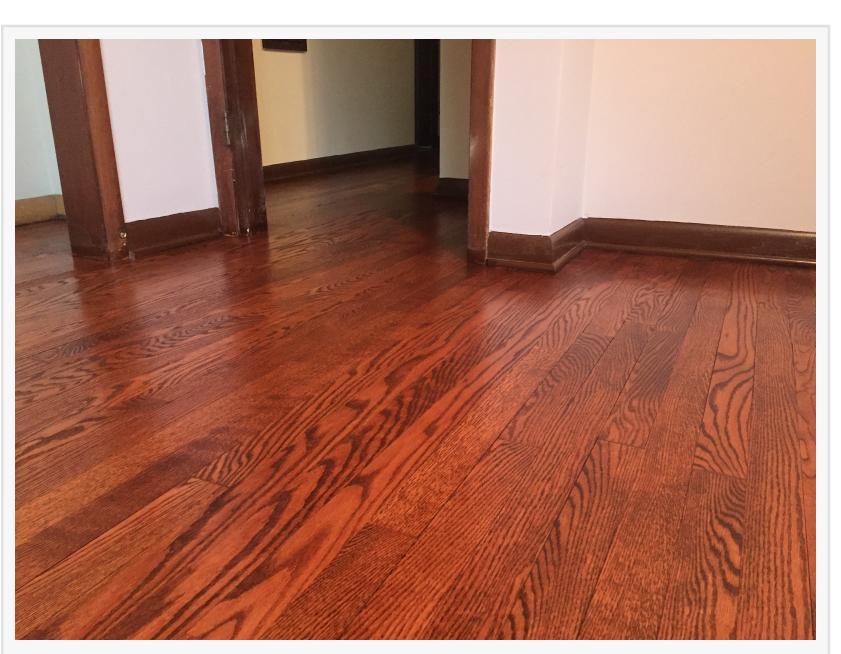
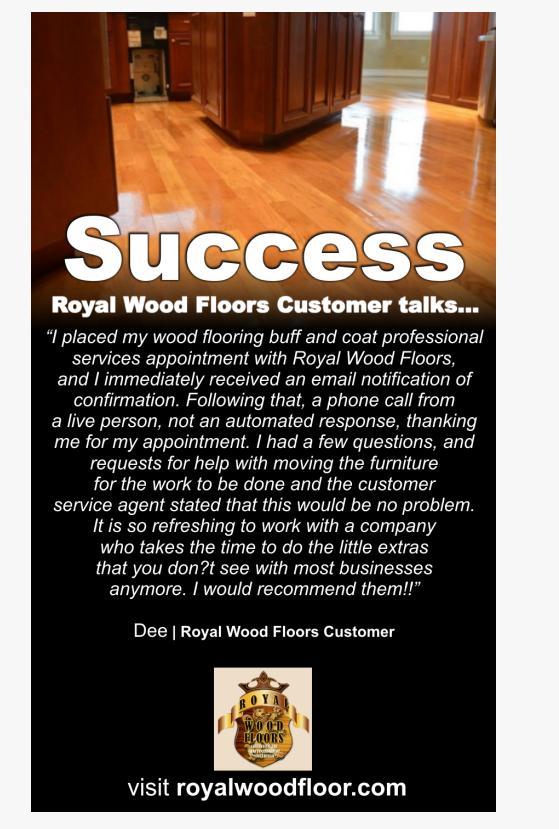
Chatter or Wave Marks are another problem that can be found with hard wood floors. Basically these are constant sanding imperfections across the grain of the wood varying from ¼ to 1-inch apart. Wave marks are two or more irregularities in a floor occurring along the direction of travel of a sander. They generally are 1 to 3 inches from peak to peak. The reason for this type of problem is because the floor was previously sanded incorrectly. The

sanding drum may have been out of balance or it may have had hard spots that could have caused the problem to begin with.

Most wave marks are caused by imperfections already present on the floor that are transferred through the wheels of the big machine to the sanding job itself. Sometimes this has happened during wood floor restorations. The cures for this type of problem are to inspect the sanding equipment being used and ensure that there are no issues with the equipment; sander. The worker that is performing the job can use a hard plate, paper disc or multi-disc sander. A sanding screen only highlights the chatter and causes the floor to dish out. You can use a disc sander and hard plate while working right to left, traveling down and back in the same path and working the disc sander at slight angles for the best cut of the unit. Repeat the same procedure, overlapping the last cut one half

the size of the first disc. "Another technique is to do a light sanding with a big machine at a 7-15 degree angle, then go over the floor again, this time straight", says Allman who maintains standards as set by the National Wood Flooring Association.
